## INSTALLATION INSTRUCTIONS

Accessory  
FRONT GRILLE

Application  
2020 ACCORD

Publications No.  
**VERSION 1**  
Issue Date  
**AUG 2019**

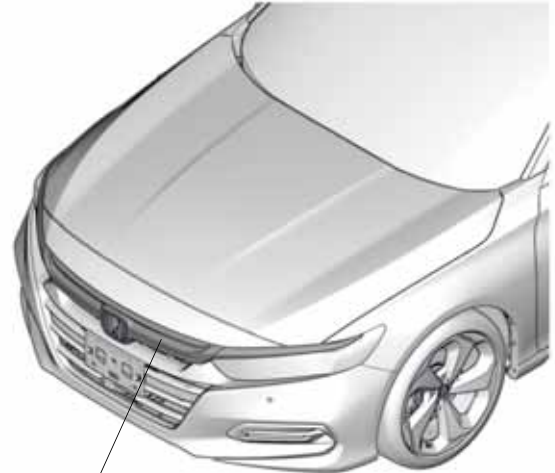
QFD2301AC

### Illustration of the Front Grille on the Vehicle

FRONT GRILLE

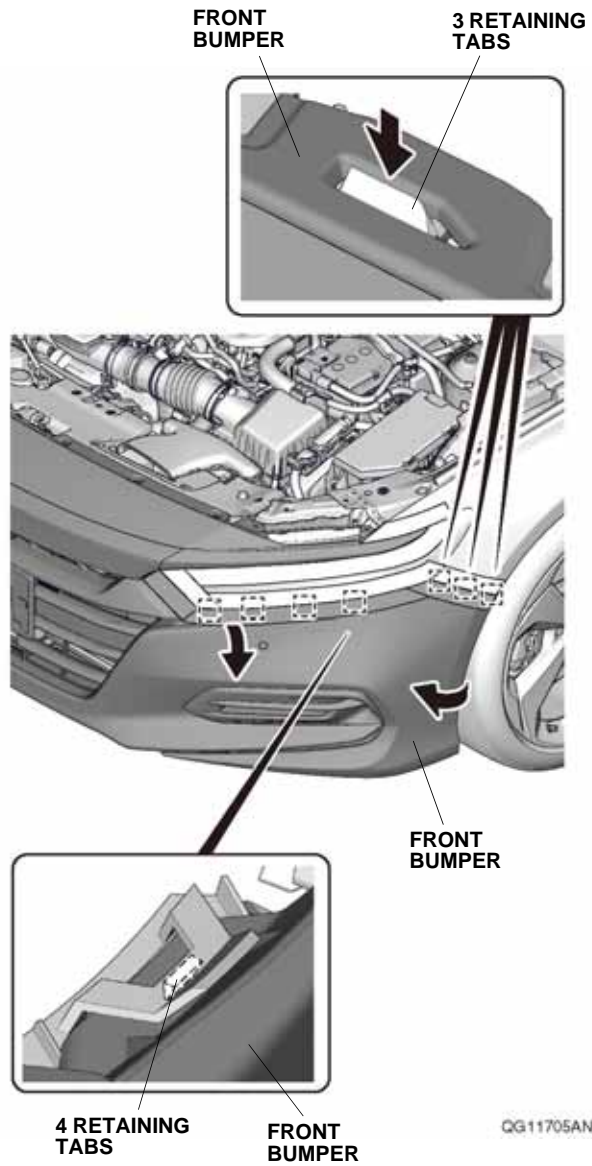
- With the help of an assistant, release the seven retaining tabs on each side.

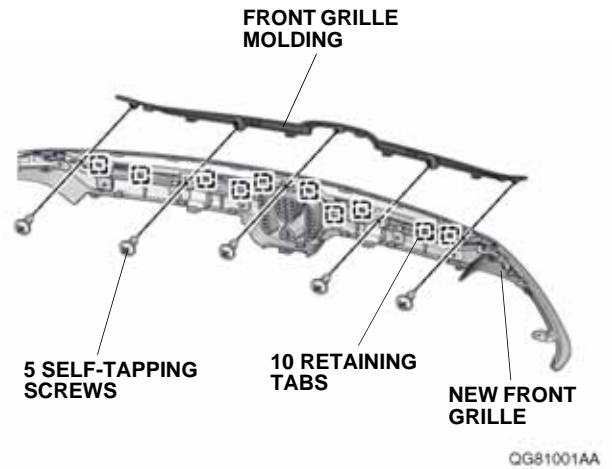
5. Install the front grille molding to the new front grille.
