INSTALLATION INSTRUCTIONS

FRONT GRILLE P/N 08F21-T7S-100 Application

2018 HR-V

VERSION 1

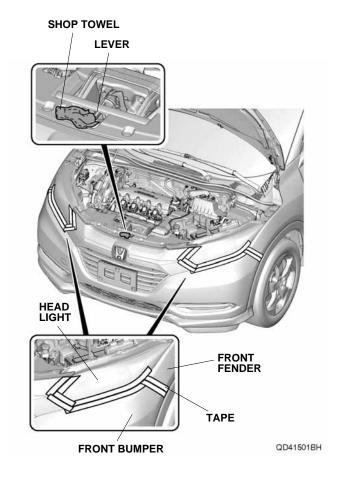
- 1. Disconnect the negative cable from the battery.
- 2. Remove the front bumper:
 - Wrap a shop towel around the lever.
 - Attach tape to the areas shown on each side.

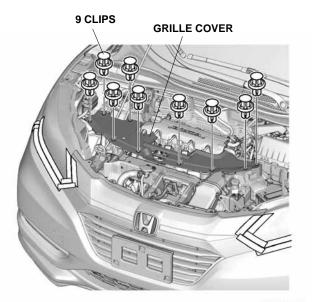
· Remove the grille cover.

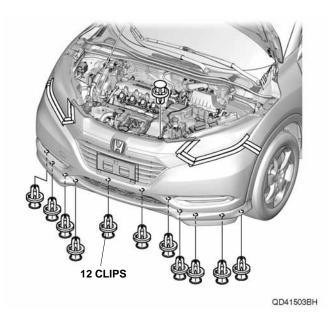
Remove the 12 clips.

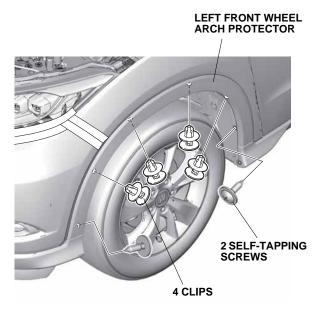
Remove four clips and two self-tapping screws on each side.

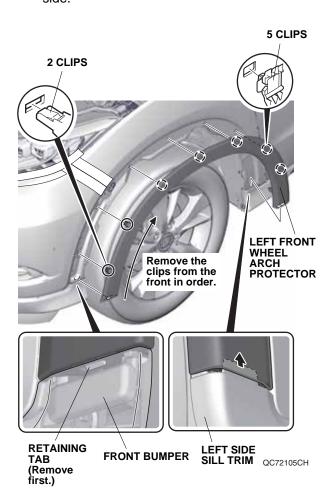
Remove the front wheel arch protector on each side.

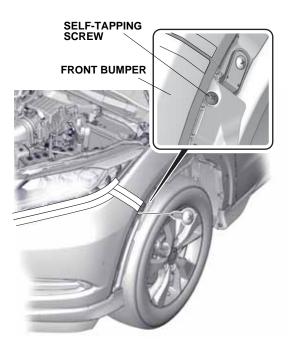
· Remove the self-tapping screw on each side.

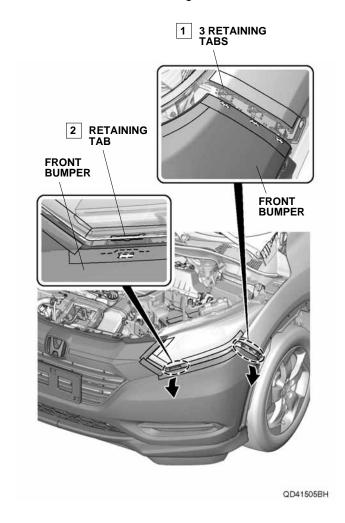
• Release four retaining tabs on each side.

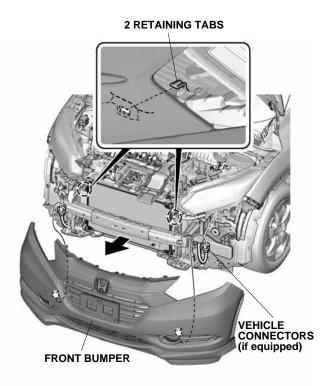
With the help of an assistant, remove the front bumper and unplug the vehicle connectors, if equipped. Place the front bumper on the blanket to prevent damage.

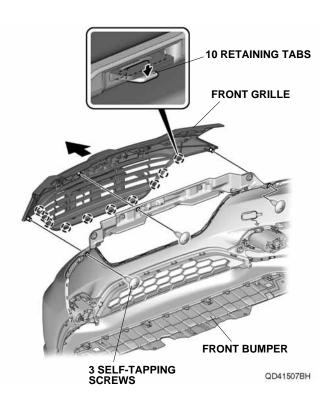
3. Remove the front grille from the front bumper.

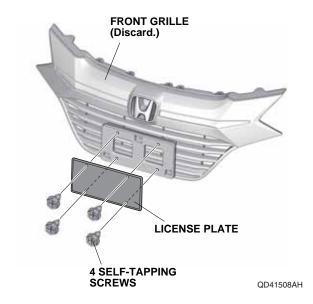
4. Remove the license plate (if installed).

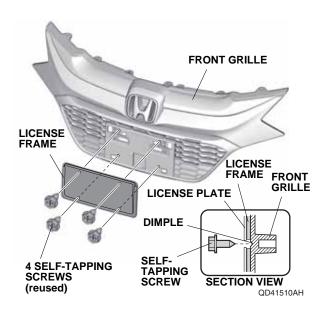
Attach the license frame to the front grille (if required).

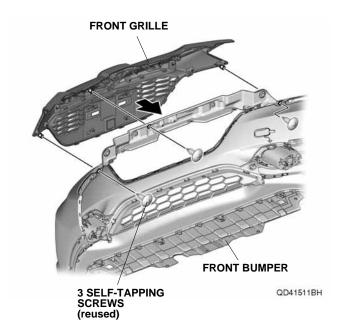
7. Install the front grille on the front bumper.
