- WHONDA INSTALLATION	Accessory RUNNING BOARDS P/N 08L33-T6Z-100A	Application 2020 RIDGELINE	Publications No. VERSION 1 Issue Date
ARTS LIST		Flange bolts	NOV 2019
eft running board			
ight running board	Rato File 13 n Toro Utilit	nm Socket jue wrench y knife	IRED
eft bracket A		ch-up paint s tration of the Running Bo a	ards on the Vehicle
ight bracket A		RIGHT RUNNING BOARD	
eft bracket C	S		
	Sec.		LEFT RUNNIN BOARD
ight bracket C	- A

INSTALLATION

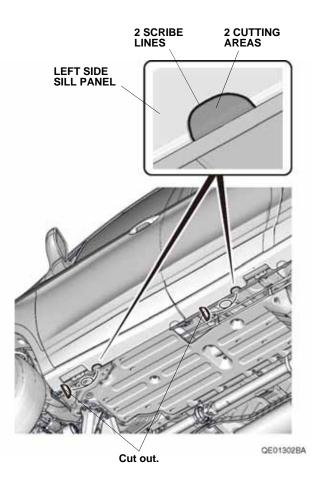
- Thoroughly clean the bottom of the body between the front and rear wheels.
- Be careful not to damage the body paint finish.
- 1. Using a utility knife, cut out the left side sill panel as shown. Remove any burrs.

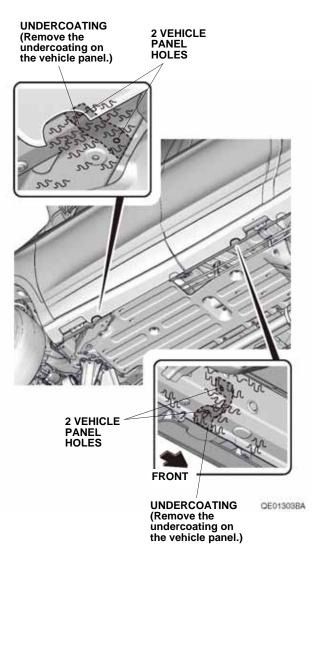
2. Remove the undercoating as shown. Apply touch-up paint where you removed the undercoating, and allow it to dry thoroughly.

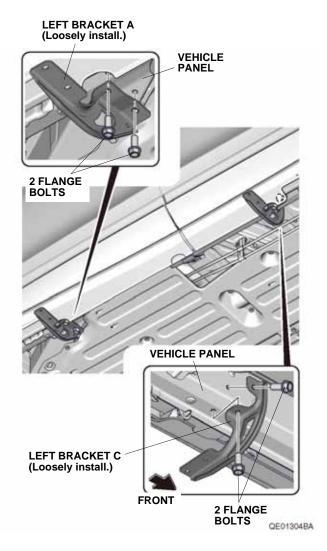
Loosely install the left bracket A and left bracket C to the vehicle panel with four flange bolts. NOTE: Make sure that the brackets are installed in the correct positions and orientations.

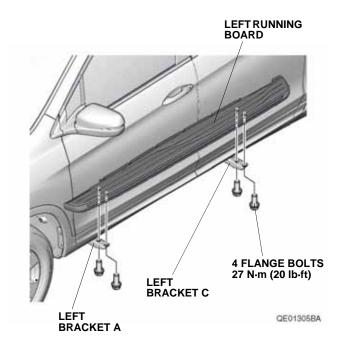
4. With the help of an assistant, install the left running board to the left bracket A and left bracket C with four flange bolts. Torque the flange bolts to 27 N·m (20 lb·ft).

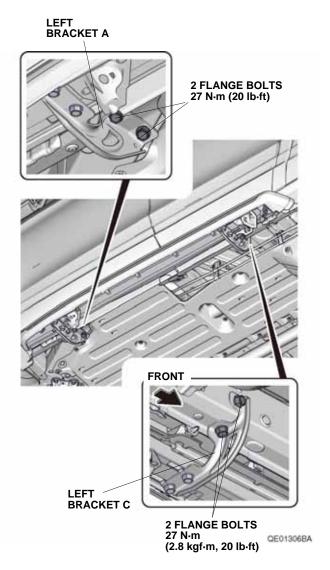
Tighten the four flange bolts loosely installed in step 3. Torque the flange bolts to 27 N·m (20 lb·ft).
