### **INSTALLATION INSTRUCTIONS**

LOWER GRILLE MOLDINGS P/N 08F21-TVA-100G

2021 ACCORD 2021 ACCORD HYBRID

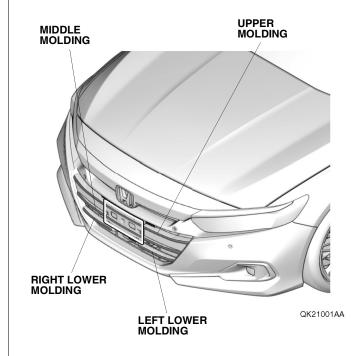
### Illustration of the Lower Grille Moldings on the Vehicle

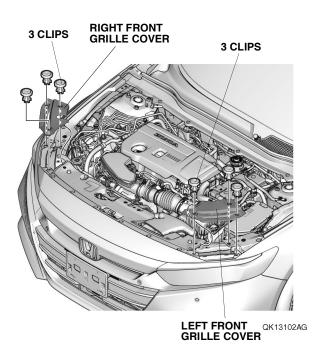
2. Remove the left front grille cover and right front grille cover.

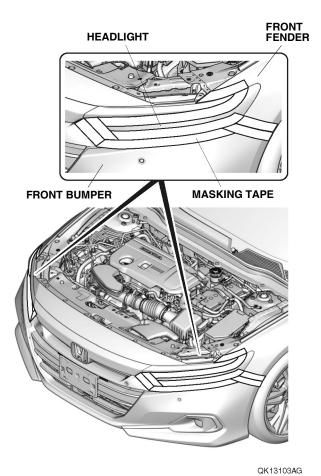
- 3. Remove the front bumper:
  - · Apply masking tape as shown.

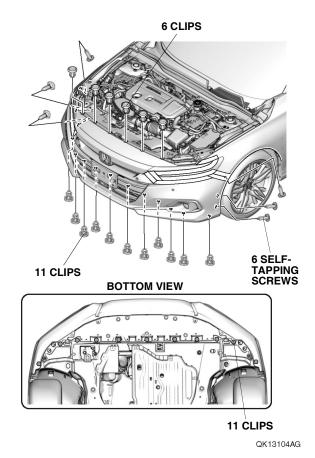
Remove the six self-tapping screws and 17 clips as shown.

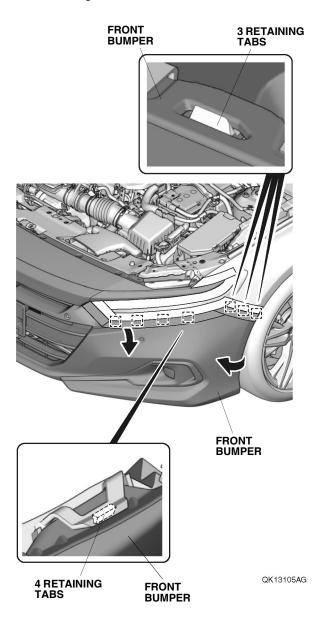
• With the help of an assistant, release the seven retaining tabs on each side.

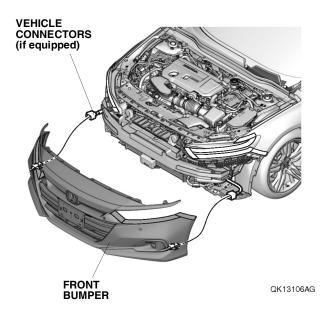
- With the help of an assistant, remove the front bumper, and unplug the vehicle connectors (if equipped).
- Place the front bumper on a blanket.

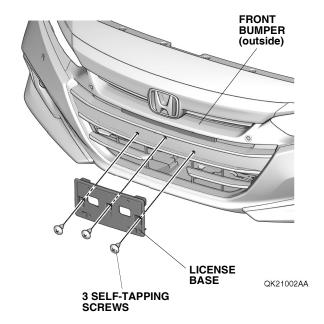
4. Remove the license base.

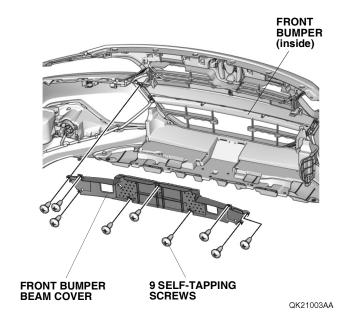
5. Remove the front bumper beam cover.

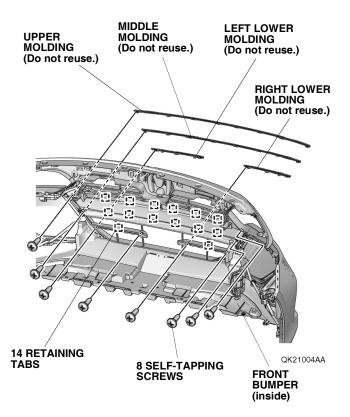
6. Remove the upper molding, middle molding, left lower molding, and right lower molding.

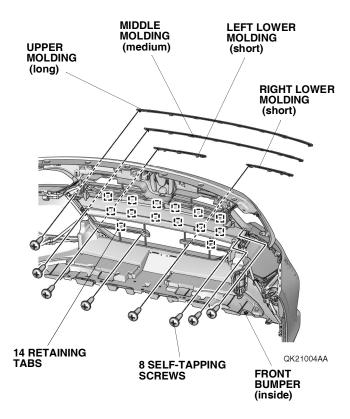
7. Install the upper molding, middle molding, left lower molding, and right lower molding to the front bumper with 14 retaining tabs and the eight self-tapping screws, removed in step 6.

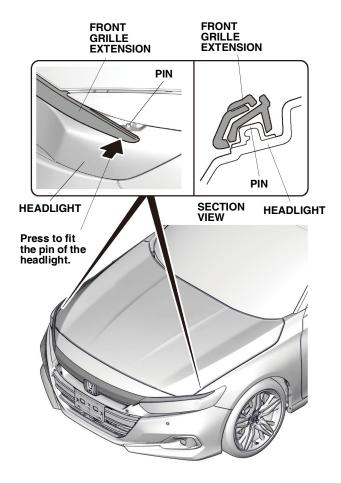
- 8. Check that all wire harnesses are routed properly and all connectors are plugged in.
- 9. Install all removed parts.
- 10. Check that the left front grille extension and right front grille extension are properly secured to the headlights. If not secured, press the edges of the left front grille extension and right front grille extension to fit the pins of the headlights as shown.
