INSTALLATION INSTRUCTIONS

LOWER GRILLE MOLDINGS

P/N 08F21-TVA-100G

2022 ACCORD 2022 ACCORD HYBRID

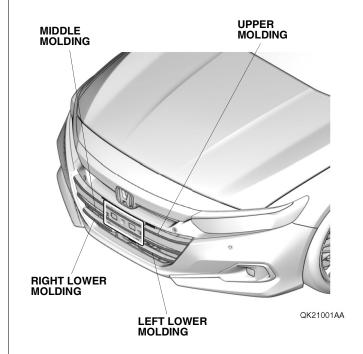
Illustration of the Lower Grille Moldings on the Vehicle

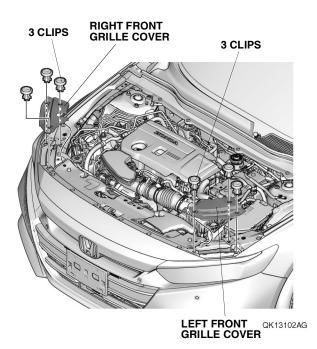
2. Remove the left front grille cover and right front grille cover.

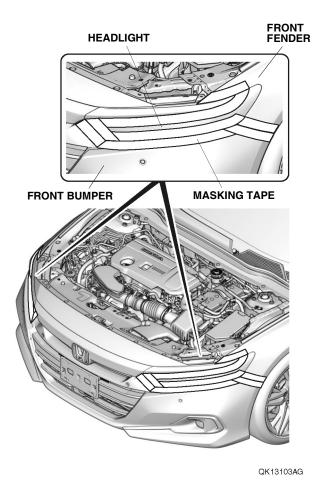
- 3. Remove the front bumper:
 - · Apply masking tape as shown.

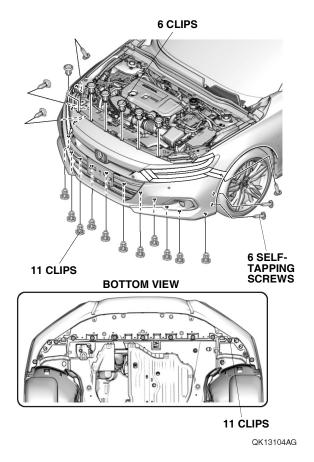
Remove the six self-tapping screws and 17 clips as shown.

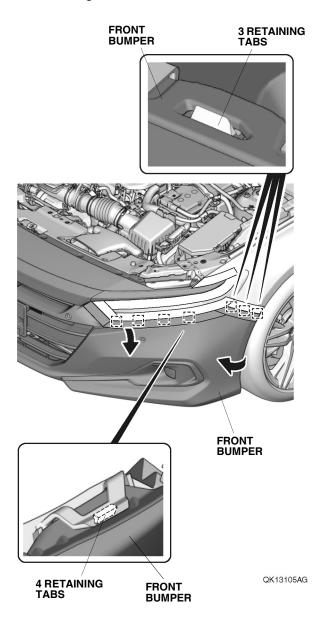
• With the help of an assistant, release the seven retaining tabs on each side.

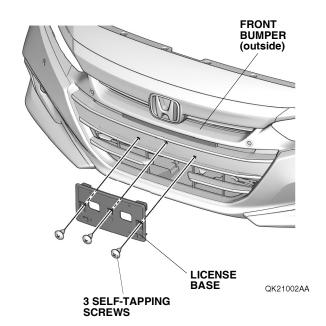
4. Remove the license base.

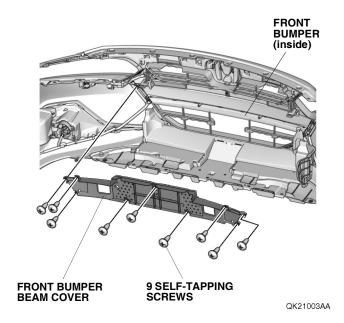
5. Remove the front bumper beam cover.

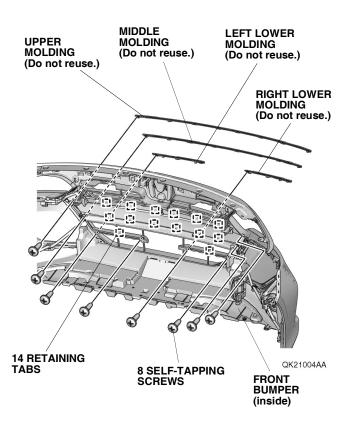
6. Remove the upper molding, middle molding, left lower molding, and right lower molding.

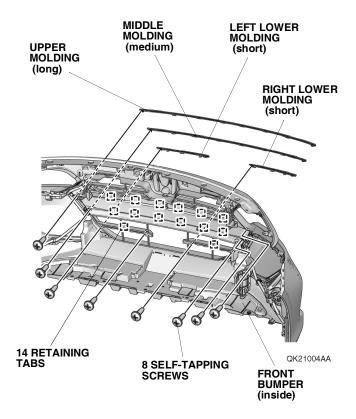
7. Install the upper molding, middle molding, left lower molding, and right lower molding to the front bumper with 14 retaining tabs and the eight self-tapping screws, removed in step 6.

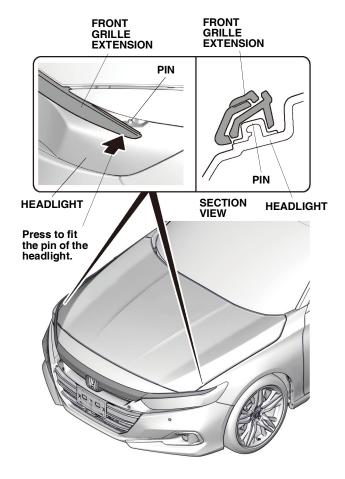
- 8. Check that all wire harnesses are routed properly and all connectors are plugged in.
- 9. Install all removed parts.
- 10. Check that the left front grille extension and right front grille extension are properly secured to the headlights. If not secured, press the edges of the left front grille extension and right front grille extension to fit the pins of the headlights as shown.
