INSTALLATION INSTRUCTIONS

FRONT GRILLE TRIMS P/N 08F21-TLA-100B Application

2020 CR-V

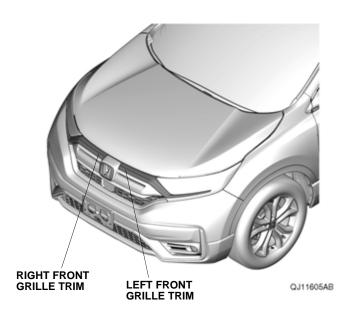
Illustration of the Front Grille Trims on the Vehicle

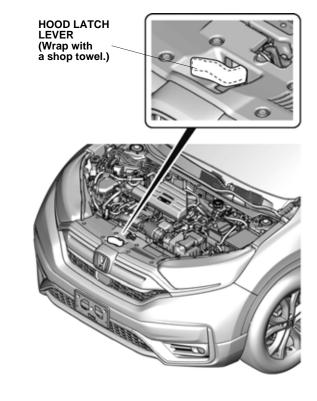
QHD2607AA

- 1. Disconnect the negative cable from the battery.
- 2. Wrap a shop towel around the hood latch lever.

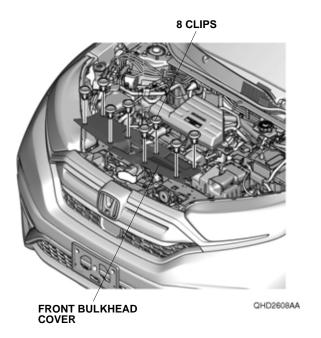
3. Remove the front bulkhead cover.

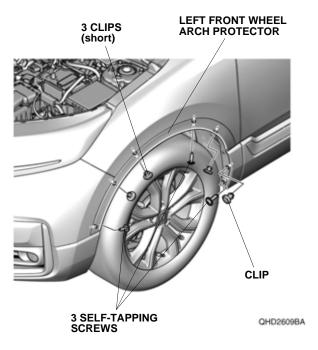
4. Remove the three self-tapping screws, one clip, and three clips (short) from the left front wheel arch protector as shown.

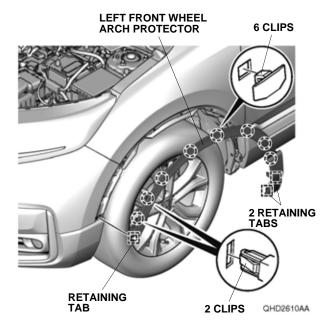
5. Remove the left front wheel arch protector as shown.

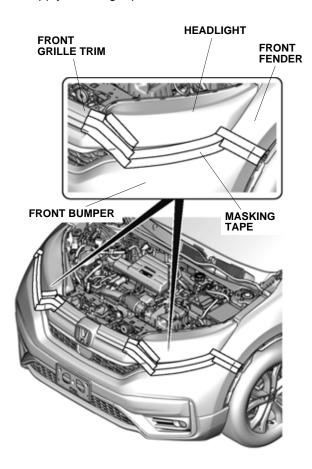
QJ20601AB

• Apply masking tape on each side as shown.

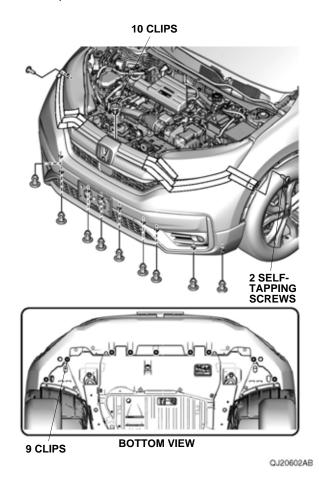
• Remove the two self-tapping screws and 10 clips as shown.

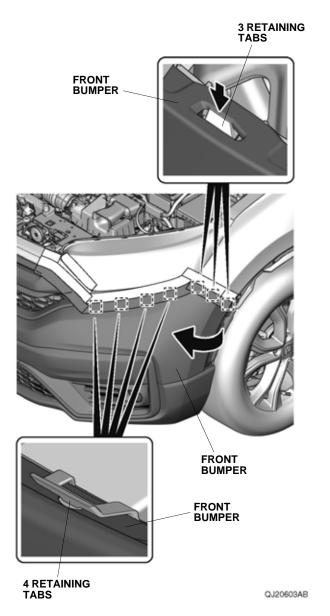
• With the help of an assistant, release the seven retaining tabs on each side.

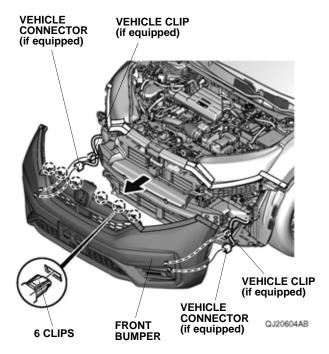
- With the help of an assistant, remove the front bumper, and unplug the vehicle connectors (if equipped).
- Place the front bumper on a blanket.

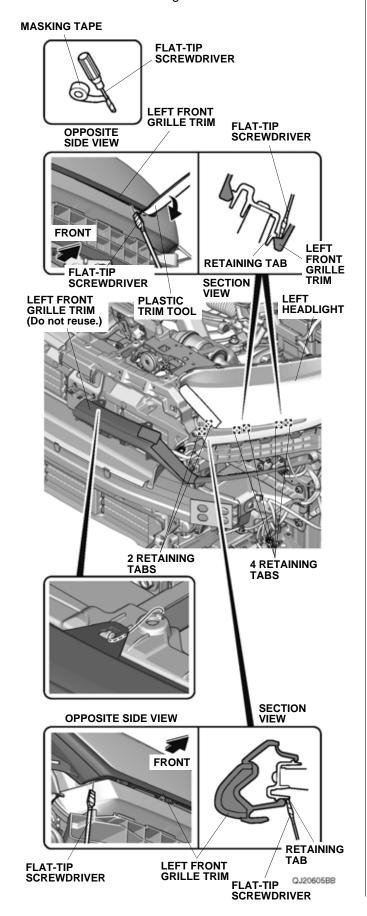
8. Remove the left front grille trim as shown.

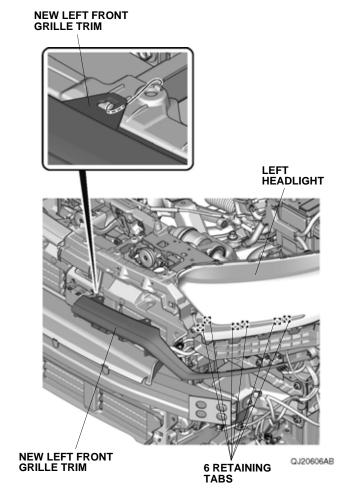
9. Install the new left front grille trim.
