INSTALLATION INSTRUCTIONS

CARGO NET P/N 08L96-T7S-100 Application

2016 HR-V

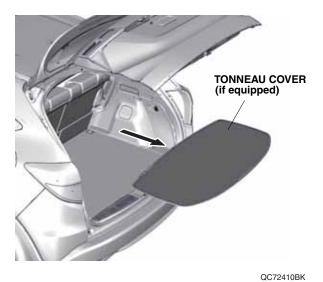
- 3. Repeat the same procedures for the other side.
- 4. Remove the tonneau cover, if equipped.

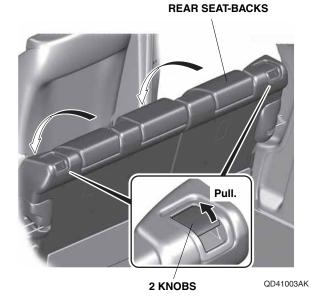
5. Pull the knobs and fold each rear seat-back forward.

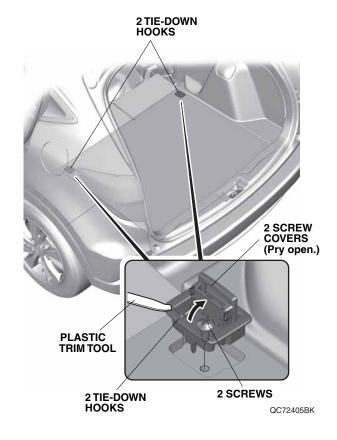
Using a plastic trim tool, pry open the screw cover.
Remove the tie-down hook (one screw). Remove the other tie-down hook.

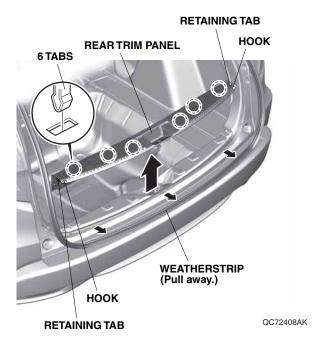
9. Pull away the weatherstrip in the area shown. Remove the rear trim panel.

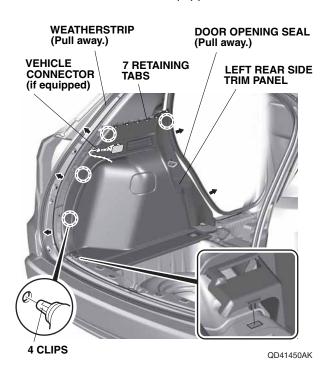
10. Pull away the weatherstrip and the door opening seal. Remove the left rear side trim panel and unplug the vehicle connector, if equipped.

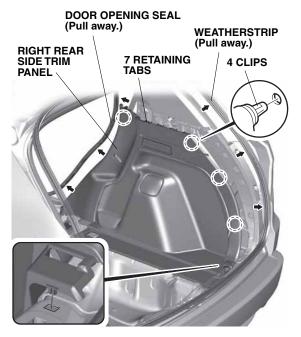
11. Pull away the weatherstrip and the door opening seal. Remove the right rear side trim panel.

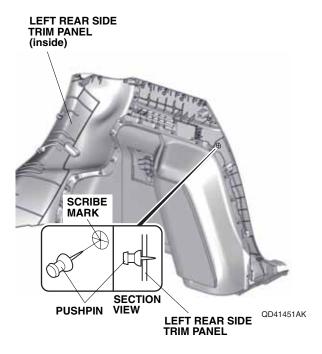
12. Using a pushpin, pierce one scribe mark on the left rear side trim panel as shown.

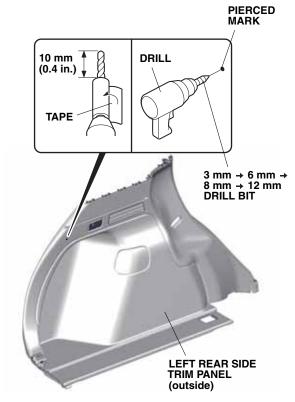
- 13. While wearing eye protection, drill a 12 mm hole in the left rear side trim panel:
 - Wrap tape around each drill bit 10 mm (0.4 in.) away from the tip or use a drill stop.
 - First drill with a 3 mm drill bit, then with a 6 mm drill bit, a 8 mm drill bit, and finish with a 12 mm drill bit.

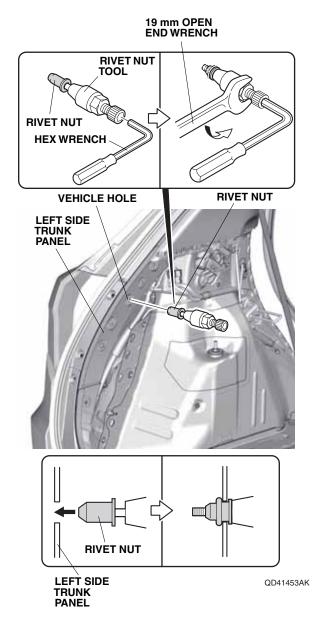
16. Insert the rivet nut into the hole in the left side trunk panel and install the hex wrench on the rivet nut tool.

- 17. While holding the rivet nut tool with the hex wrench, turn the 19 mm wrench counterclockwise and install the rivet nut into the hole in the left side trunk panel. Remove the tool from the rivet nut by turning the hex wrench counterclockwise.
- 18. Reinstall the left rear side trim panel.

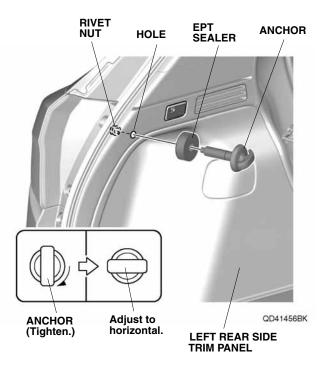
20. Install the EPT sealer onto anchor and thread the rivet nut onto the stud bolt. Adjust the anchor as shown.

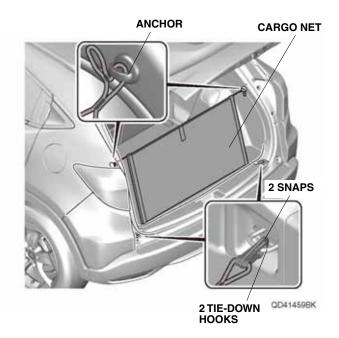
Attach thew top loops on the cargo net to the two anchors. Attach two snaps on the cargo net to the tie-down hooks.

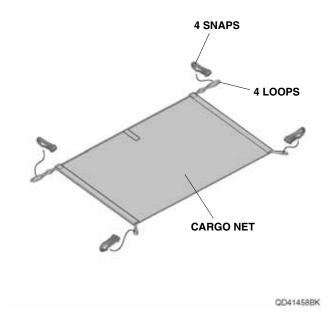
• Attach four snaps to the cargo net as shown.

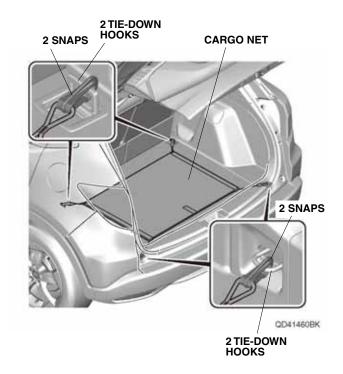
Attach the four snaps on the cargo net to the tie-down hooks as shown.
